Update HFR • number 2 • 25 March

Phase 1 progresses successfully Vessel inspection reaches a positive conclusion Densimet base radiation shield

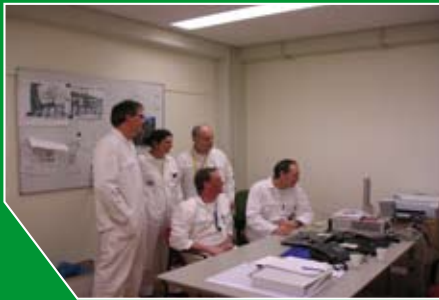
The inspection team at work.

Last week, the regular inspection of the HFR reactor vessel was completed successfully. In response to new technical developments and in keeping with NRG's goal of continuous improvement; the inspection programme for the reactor vessel has been extended. As part of this, the inspection was conducted using a new mast and manipulator system. The inspection team also used a new inspection technique (phased array), which allows measurements to be made more quickly and with more precise results. These improved techniques now make it possible to measure welds that were previously difficult to reach. Working in double shifts, the NRG Safety & Power inspection team completed the inspection one day earlier than planned. The inspection results show that the welds are in good condition. The results have been approved by the inspection supervisor Lloyd's Register and the Dutch Regulator. This left the road open for the next phase of the repair process; the installation of the radiation shielding materials in the reactor tank.
