Update HFR • number 1 • 19 February

HFR repairwork started Concrete test rigs IAEA satisfied with repair plan

HFR repairwork started

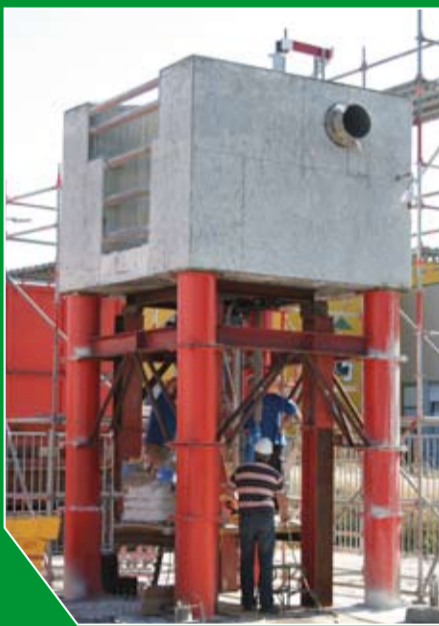
Drilling in the mock up

Checking the concrete of the mock up

Top view of the mockup

Repairwork on the cooling water pipework has been practised extensively in recent months. At the Strukton site in Maarssen, test rigs were erected of the Bottom Plug Liner, the bottom section of the reactor where the repairwork will be carried out. Adopting this approach made it possible to confirm that reaching and repairing the damaged parts would be feasible.
