Update HFR • number 2 • 25 March

Phase 1 progresses successfully Vessel inspection reaches a positive conclusion Densimet base radiation shield

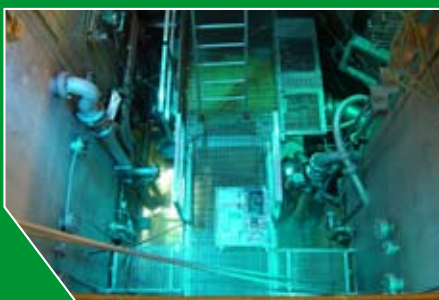
Placement of the temporary grids

During the repair, a base radiation shield made of Densimet will protect the workers against the residual radiation emanating from the reactor core area. Positioning the base shield is a precise exercise that requires meticulous preparation. Shield Project Managers Chris van Wijk and Johan Best were closely involved in these preparations as well as in performing the work itself. "The Densimet shield is manufactured from a tungsten alloy and was made especially for this purpose. It has a density of nineteen kilos per litre, that is one and a half times denser than lead. It was decided to use this material, because on the one hand it's dense enough to block the radiation and on the other hand it's easy to cut to the required size," explained Van Wijk. Manipulators are used to install the base shield in numbered parts like a jigsaw. The team recently practiced this process on the HFR site. Best says: "Almost all the parts were made to measure, so that they fit exactly. Where necessary, we were able to reshape certain parts while we were practicing how to install them. We then laid the parts out in sequence and stored them in containers so that they were ready to be positioned". The team has installed the Densimet radiation shield in the base of the half drained reactor tank. To shield the reactor core itself, a kind of folding 'butterfly' has been designed and manufactured from coated Densimet. This will also be positioned using a manipulator. Once the full base radiation shield has been fully installed, a 40cm-thick concrete plate will be positioned over the top of the reactor tank so that the repairs can be carried out safely.

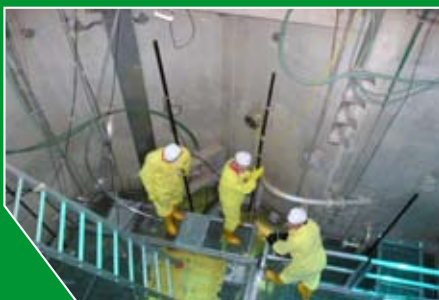
Working on the temporary grid in the vessel.
